ADDENDUM #2

WATER TANKS

ANNUAL CONDITION ASSESSMENT

Roper Tank

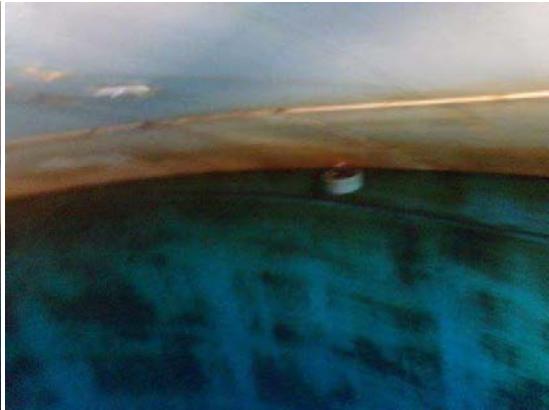
Coatings		
Interior Condition		
Not Inspected, Apparent Corrosion Present

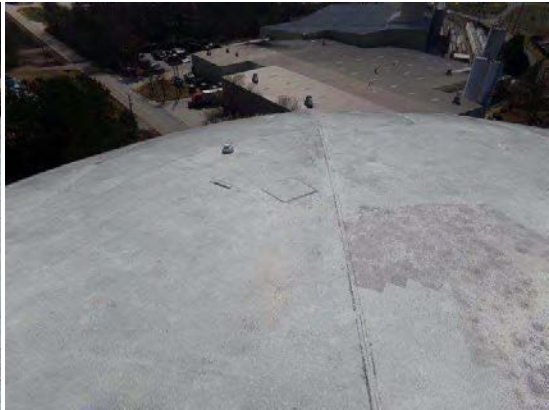
Exterior Condition		
Renovation Should Be Considered In Near Future

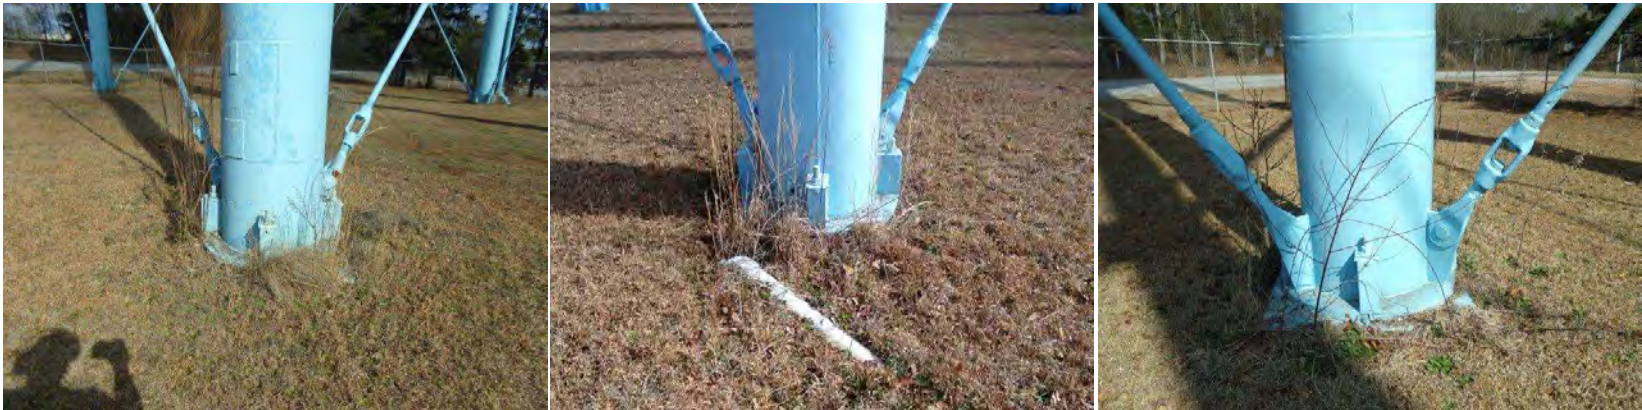
Legs

Coating Separation And Light Mildew

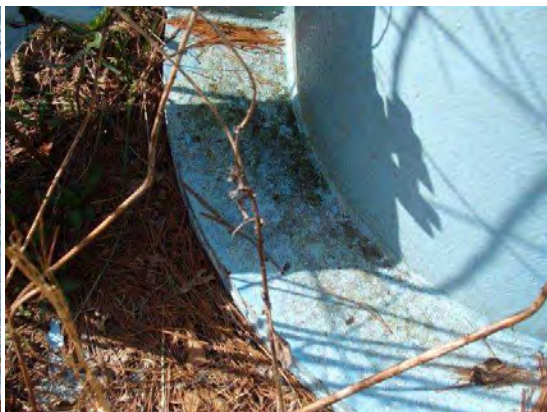
Column Flanges

Minor Corrosion And Flaking Finish Coat

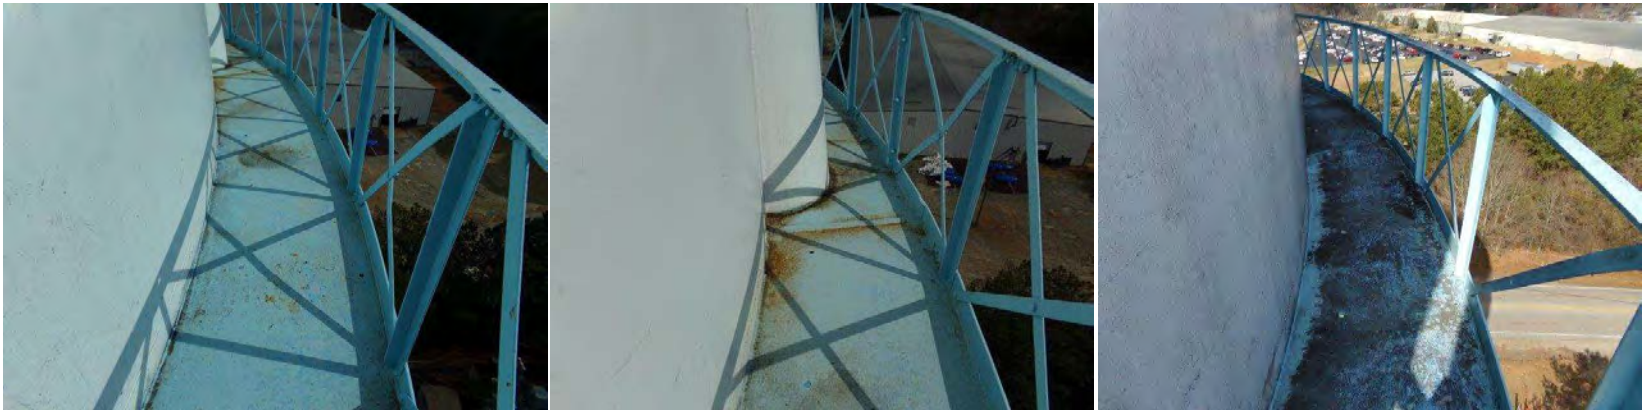
Balcony

Minor Corrosion And Heavy Mildew Present

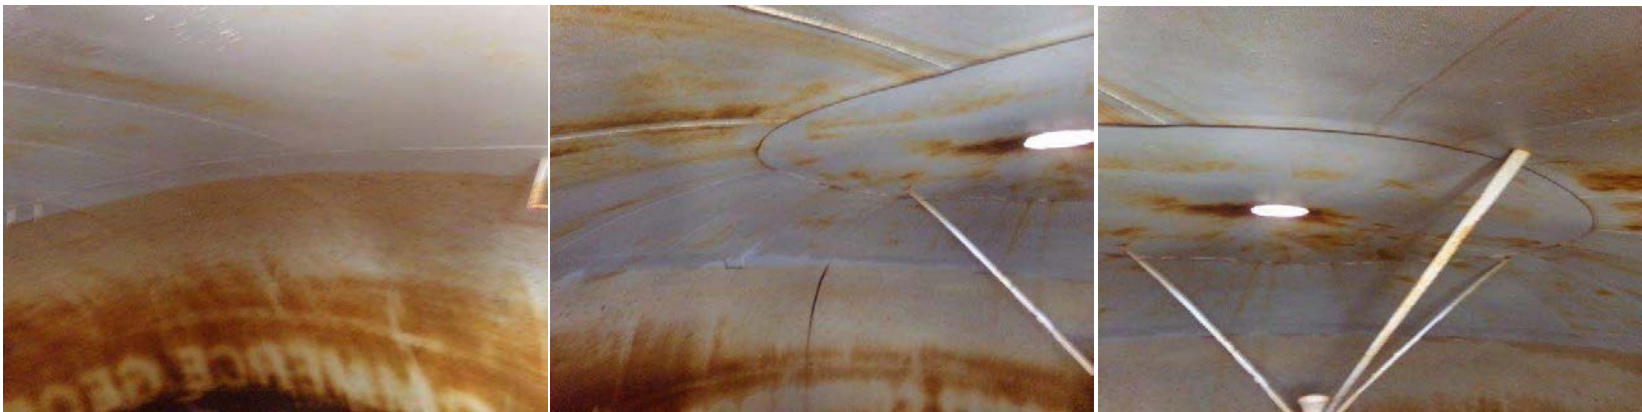
Interior Condition

Not Inspected, Apprarent Corrosion Present. Renovation Should Be Considered In Next 12 Months

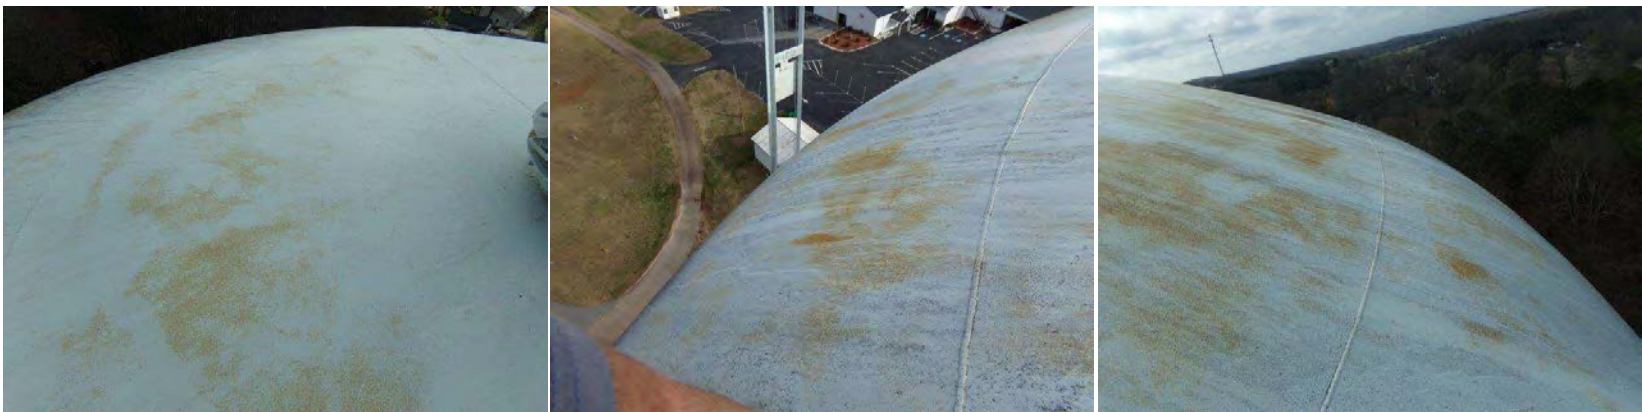
Exterior Condition

Renovation Should Be Considered In the Next 12 Months

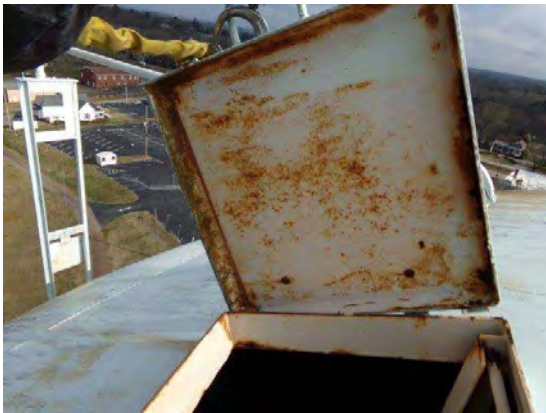
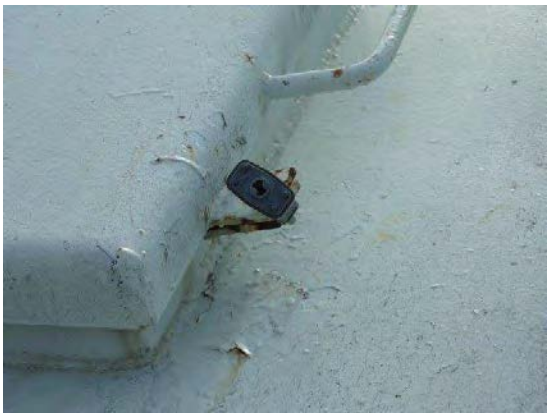
Entry Hatch #1

Corrosion Present, New Hinges Should Be Installed

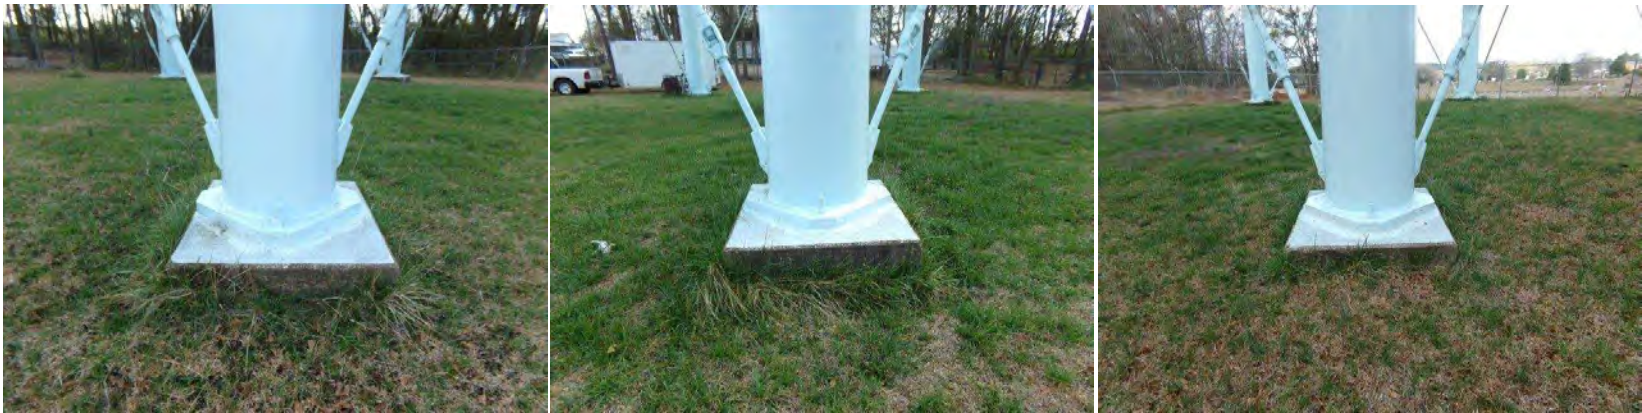
Legs

Heavy Growth And Mildew Present

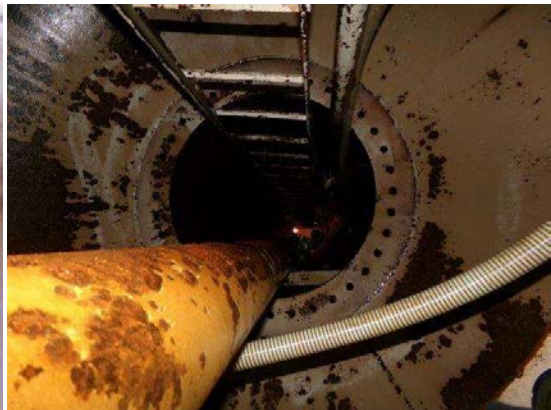
Interior Condition

Renovation Should Be Scheduled In Near Future

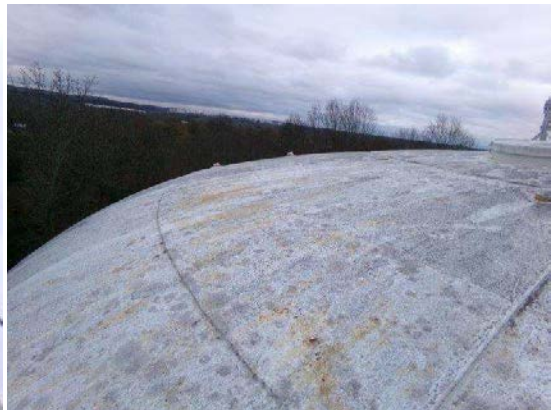
Exterior Condition

Renovation Should Be Scheduled In Near Future

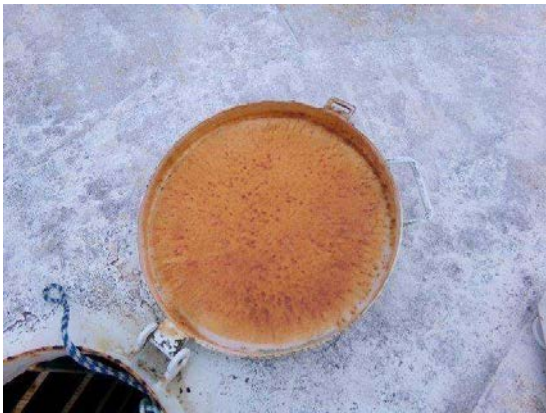
Entry Hatch #1

Corrosion Present

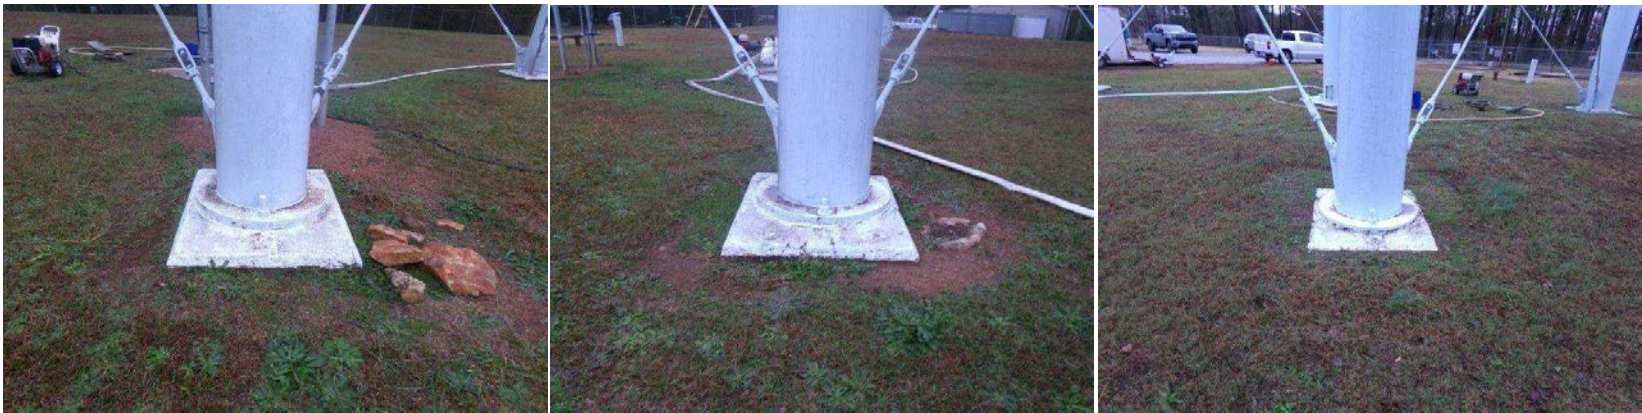
Legs

Minor Corrosion Present

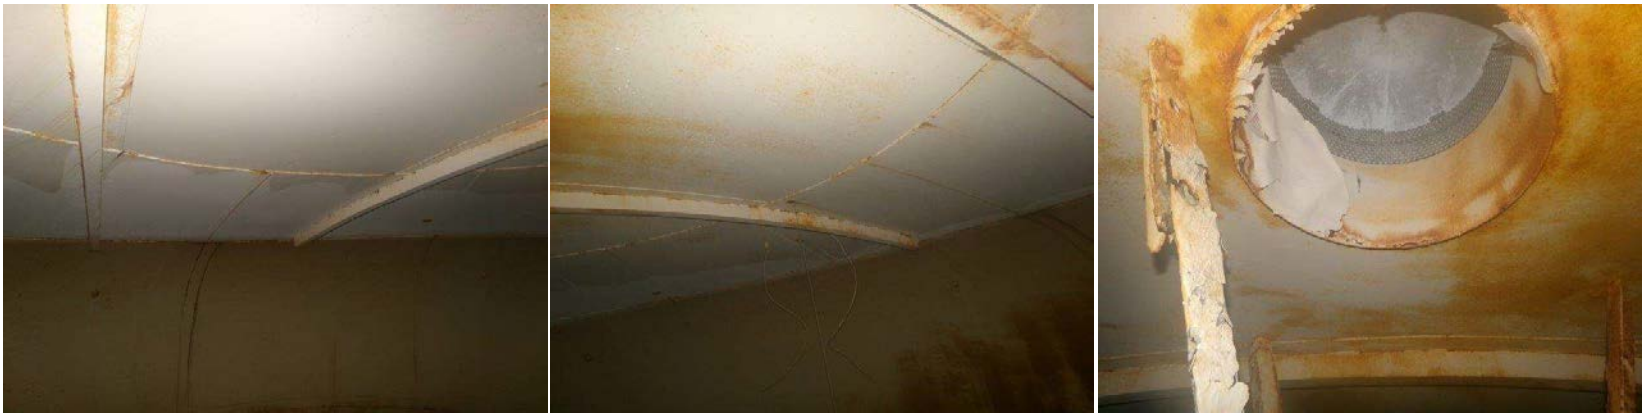
Int. Roof

Corrosion Present

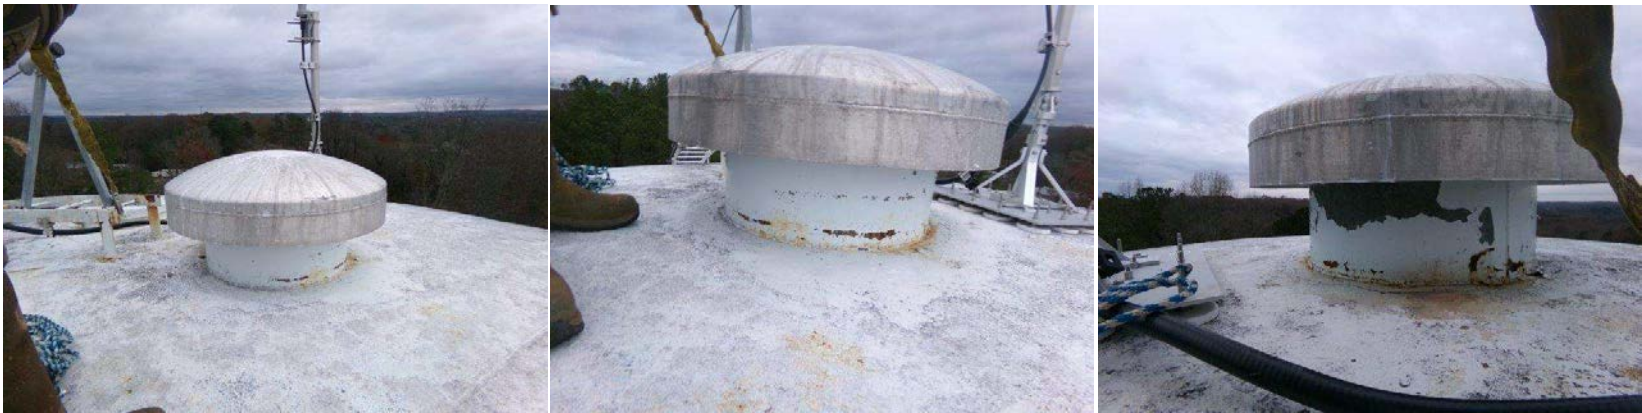
Vent # 1

Corrosion Present
