ADDENDUM #2

WATER TANKS

ANNUAL CONDITION ASSESSMENT

Roper Tank

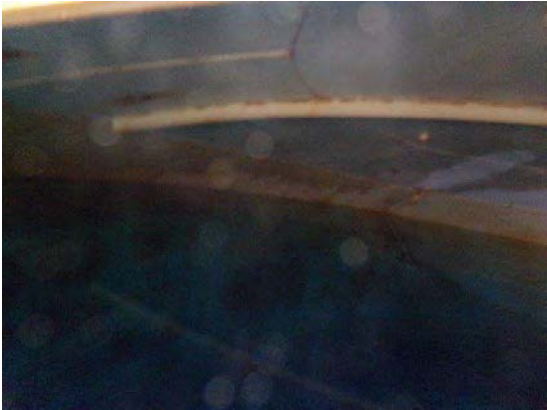
Coatings		
Interior Condition		
Not Inspected, Apparent Corrosion Present

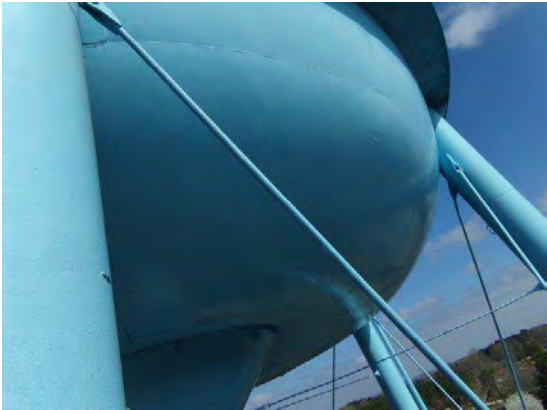
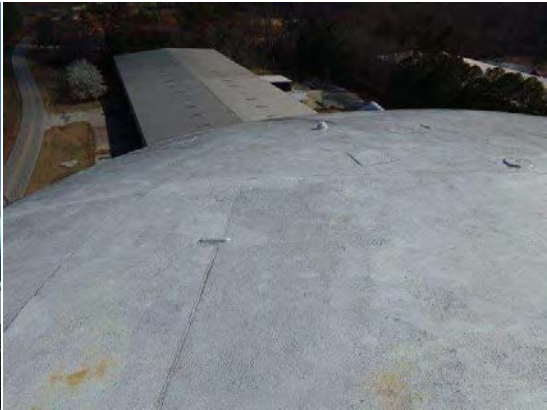
Exterior Condition		
Renovation Should Be Considered In Near Future

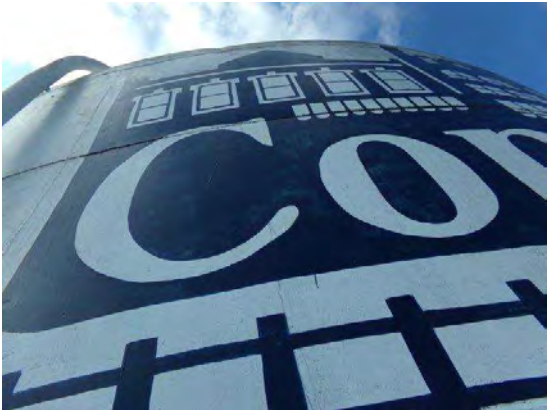
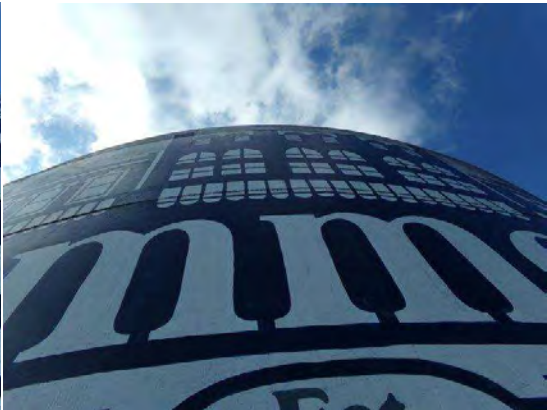
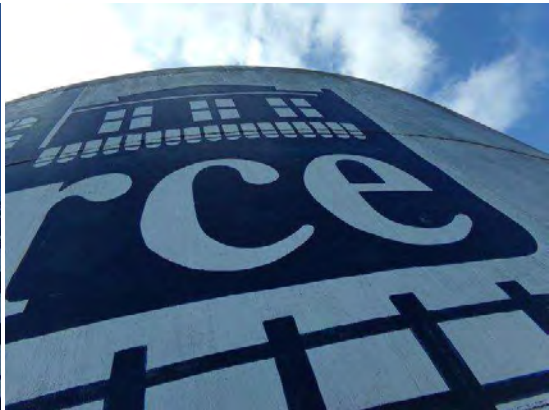
Logo Appearance		
Retrace at Exterior Renovation

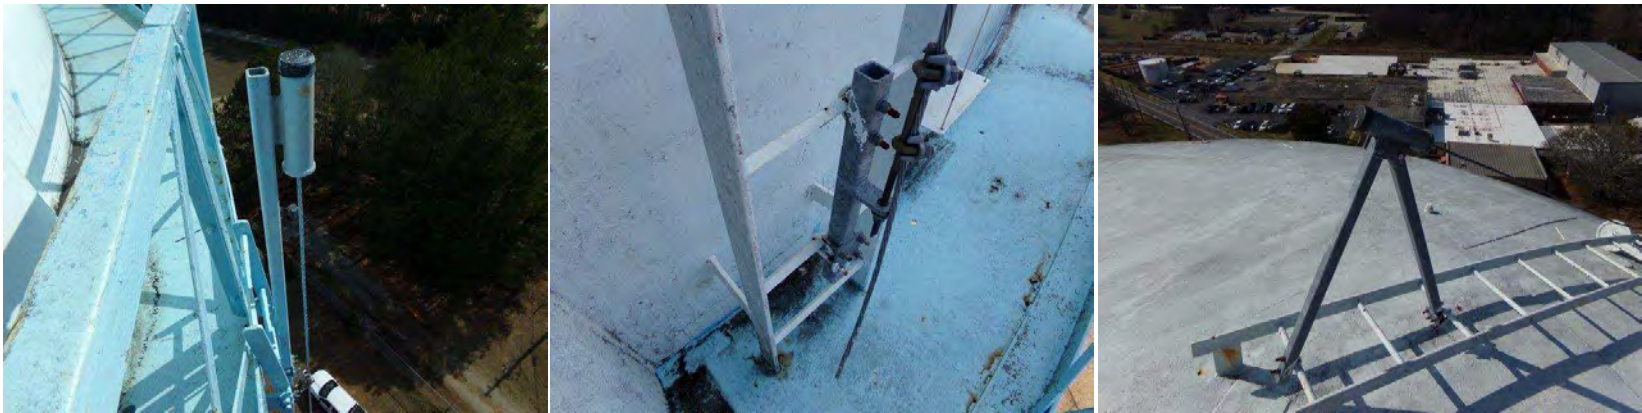
Entry Hatch #1

No Corrosion & Secure

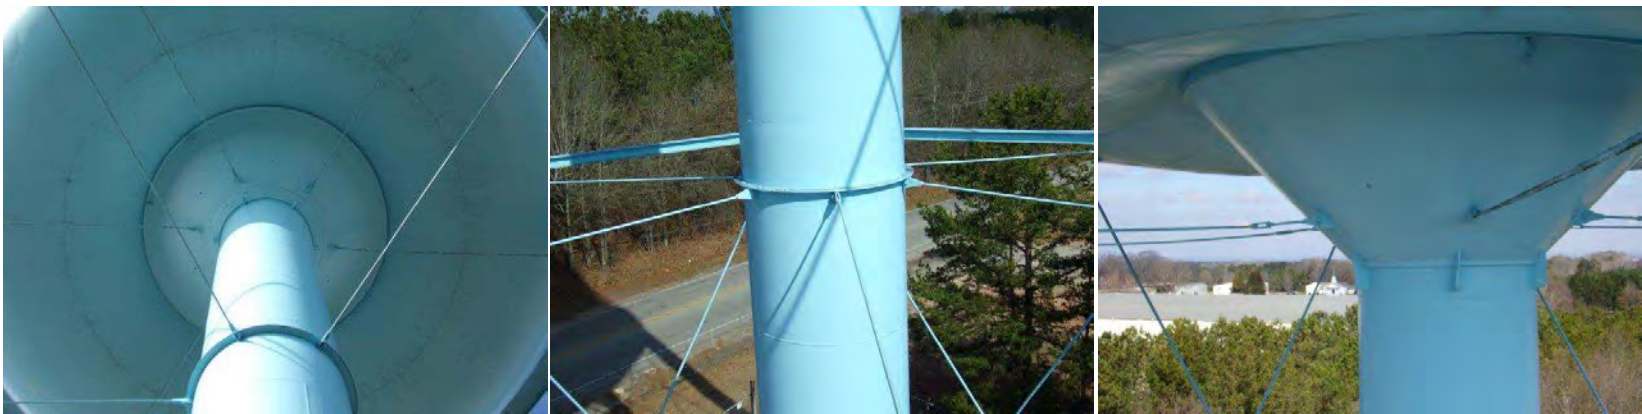
Wind Rods

Turnbuckles & Connection Points Good

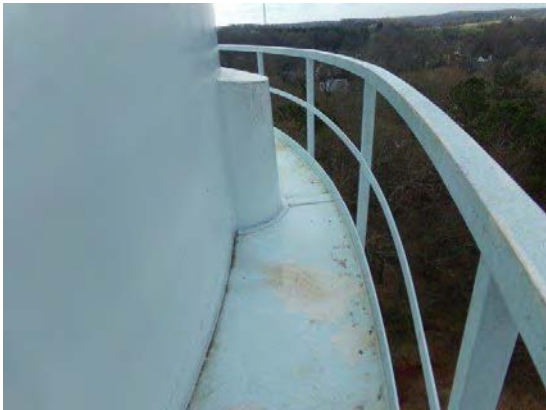
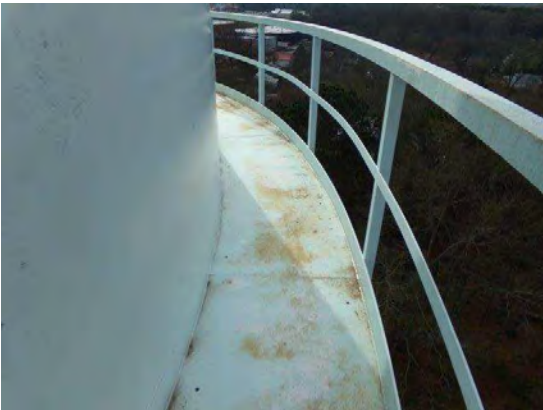
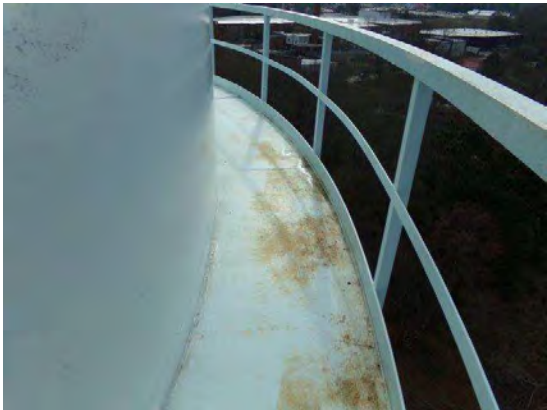
Balcony

Corrosion Present

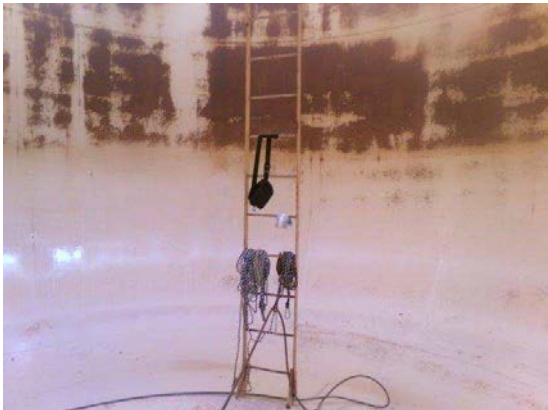
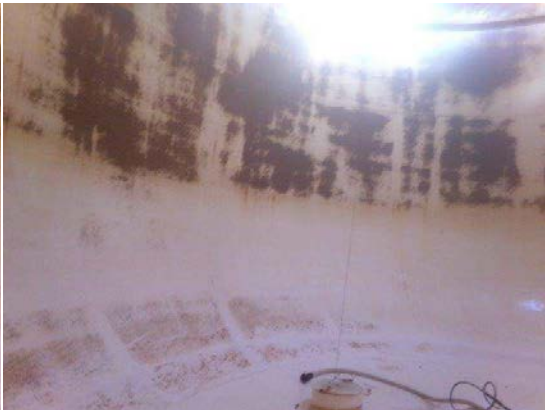
Interior Condition

Renovation Should Be Scheduled In Near Future

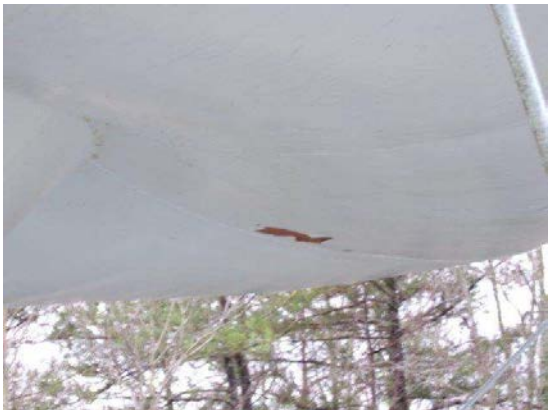
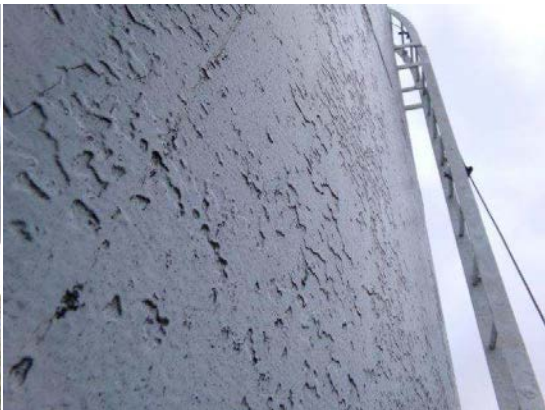
Exterior Condition

Renovation Should Be Scheduled In Near Future

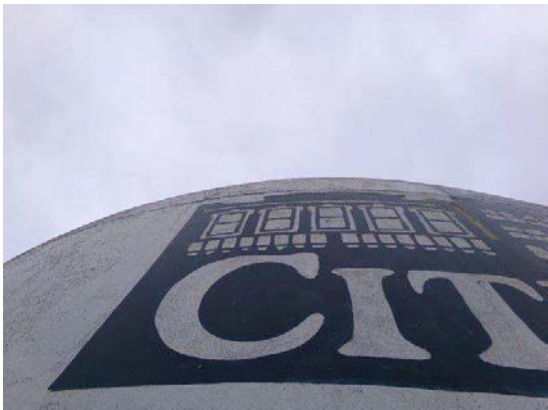
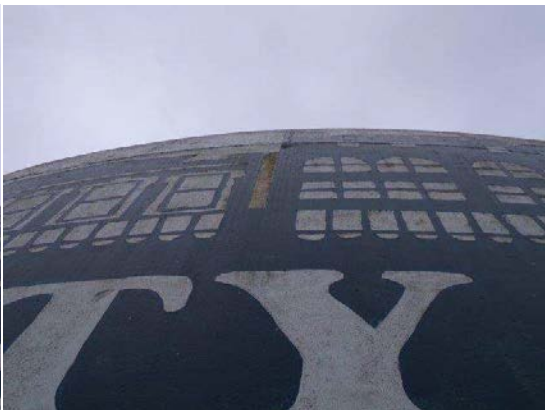
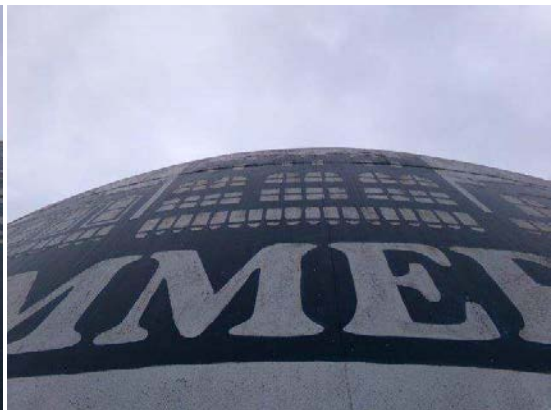
Logo Appearance

Retrace at Exterior Renovation

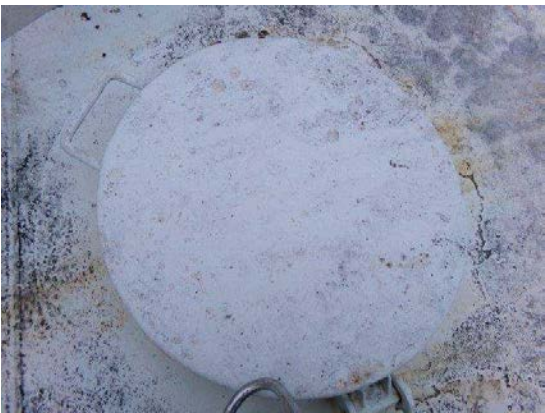
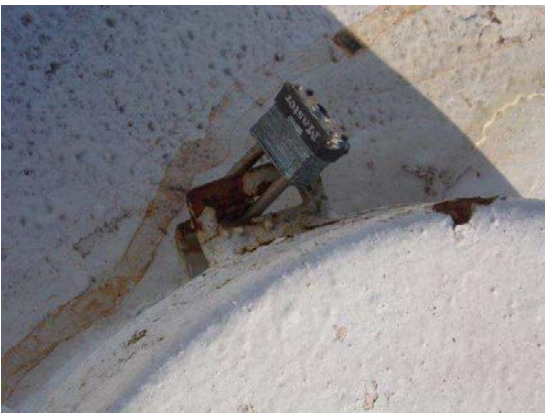
Entry Hatch #1

Corrosion Present

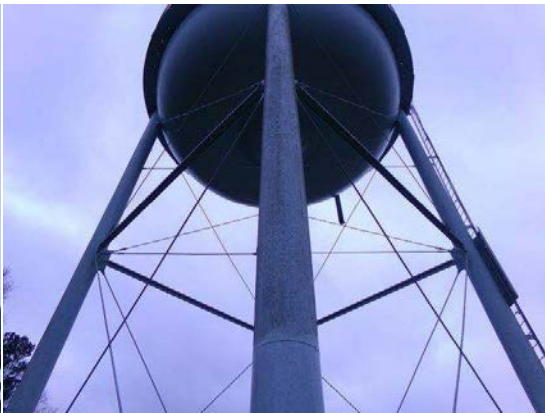
Minor Corrosion Present

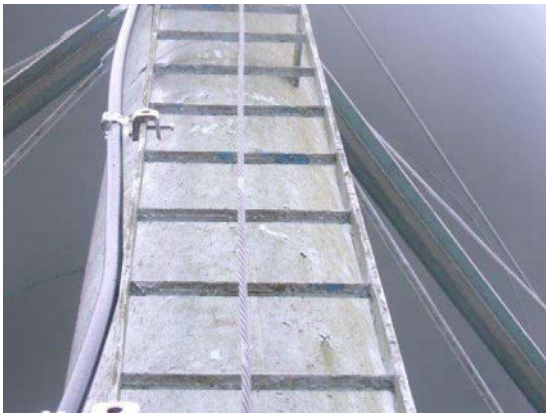
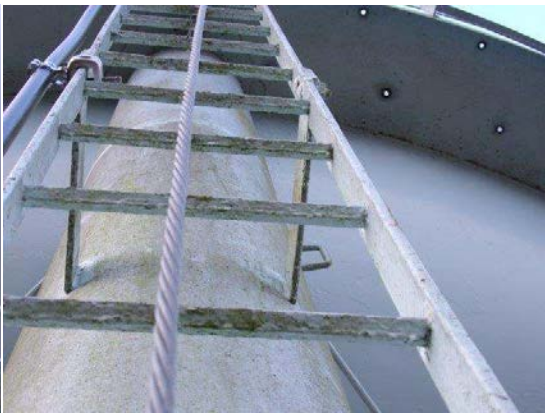
Access Ladders

Corrosion Present

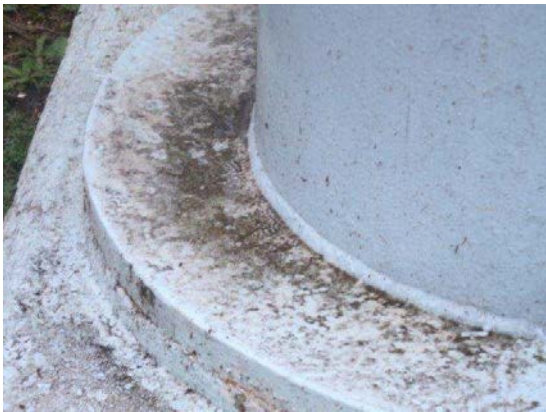
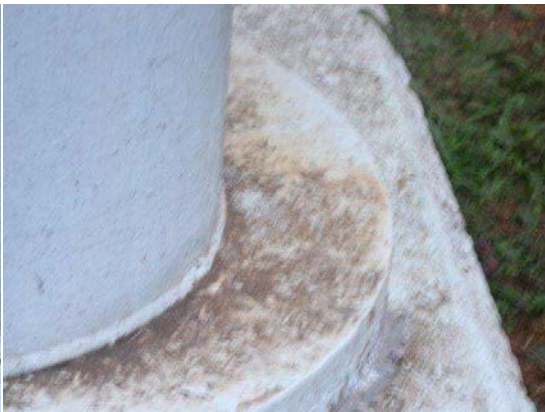
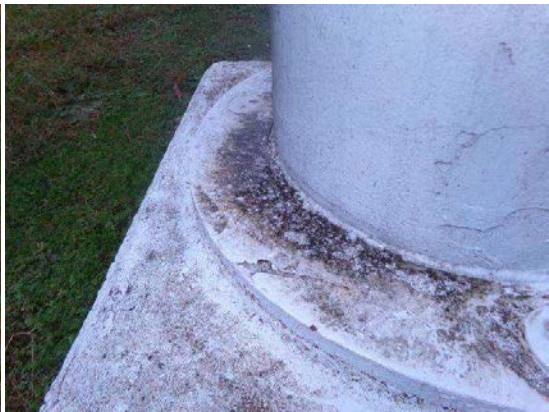
Column Flanges

Minor Corrosion Present

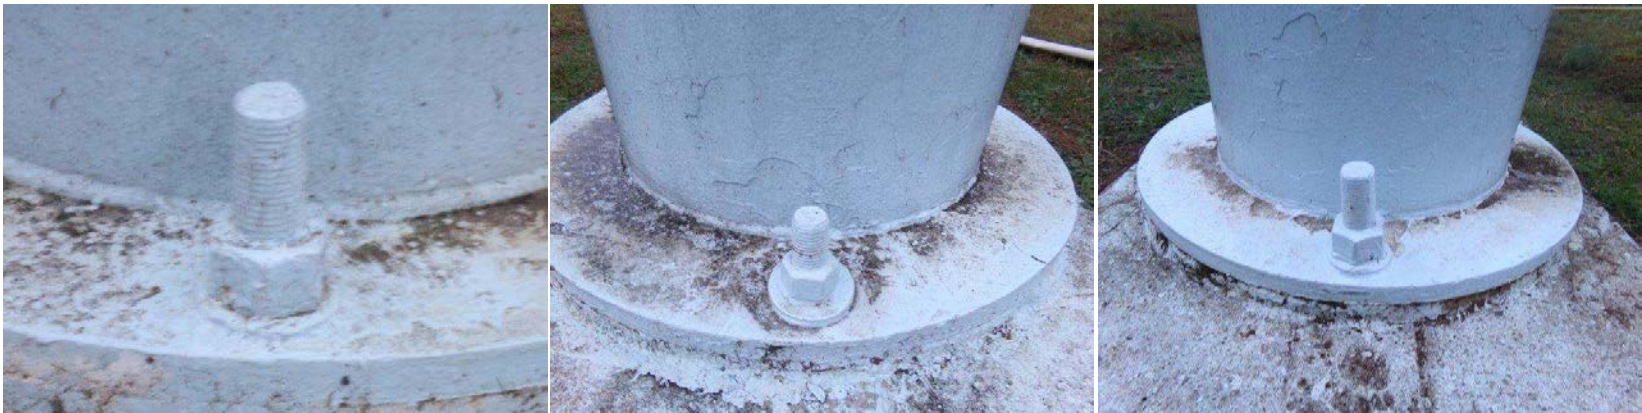
Anchor Bolts

Minor Corrosion Present

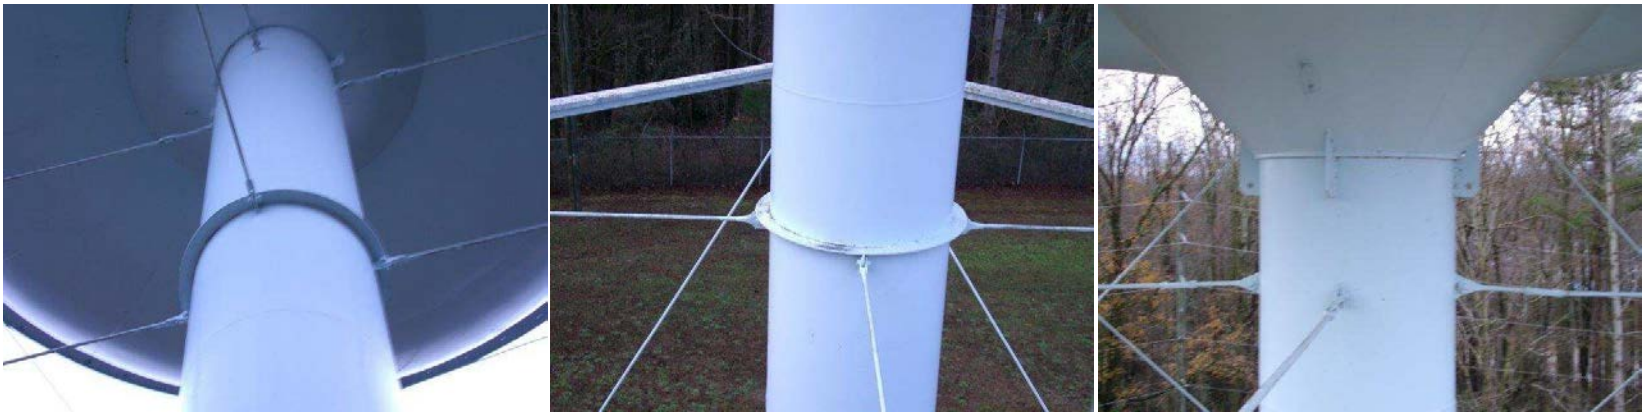
Riser Rods

Minor Touch Up Needed

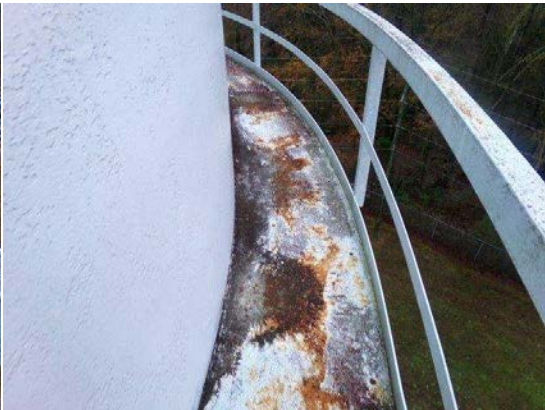
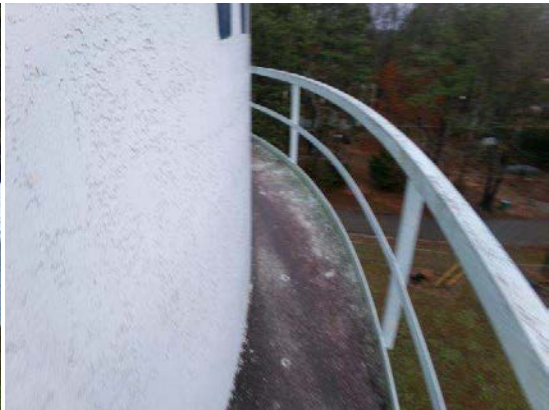
Balcony

Drainage Issues, Needs Repair and Corrosion Present

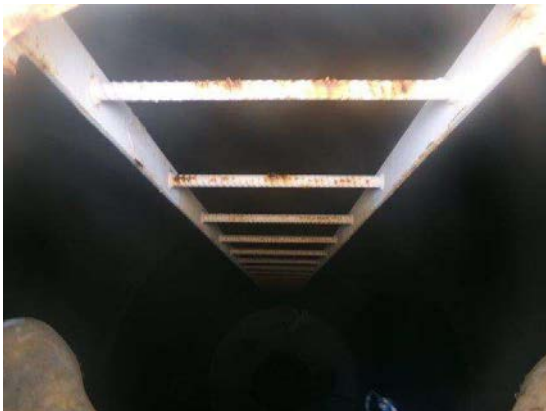
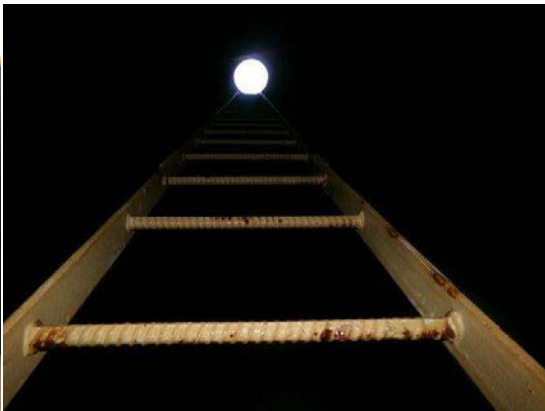
Interior Ladders

Touch Up Repair Needed
